MOULSONS POND DAM

CT 00420

PHASE I INSPECTION REPORT

NATIONAL DAM INSPECTION PROGRAM

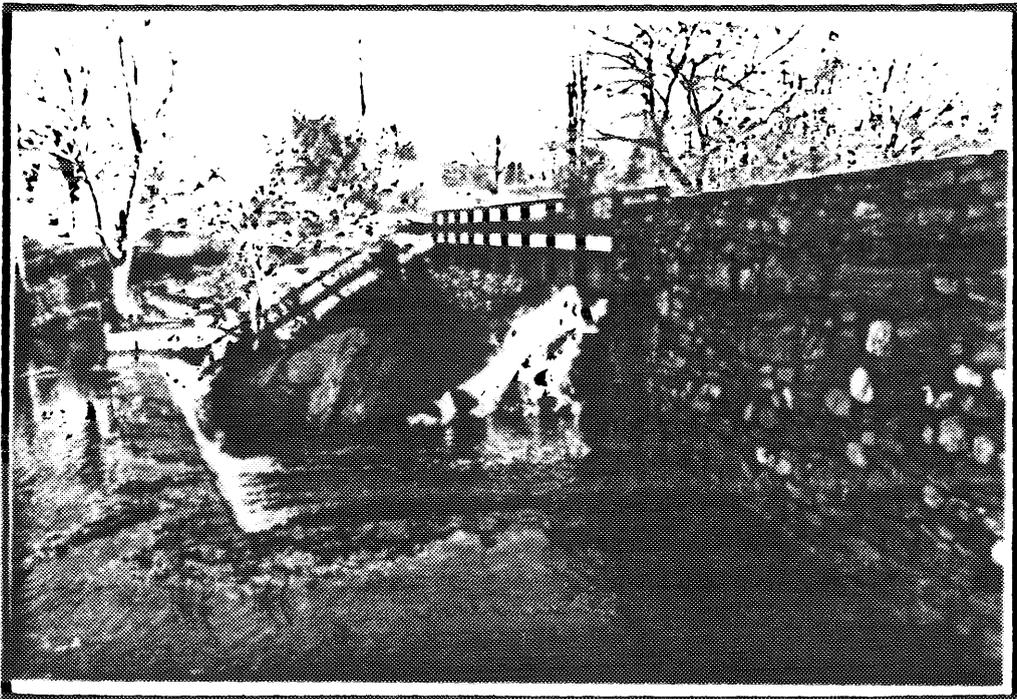
SPILLWAY - DOWNSTREAM BRIDGE
